# Manhole Inspection Summary

Manhole # **S15C\_\_008MH**

Insp Date: **10/5/07 12:06 PM**

**Location** Address: **231 FRANKLIN ST**

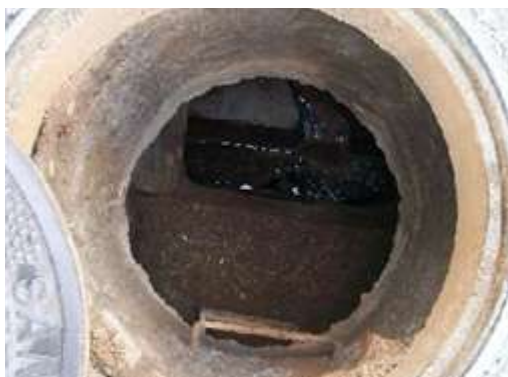
Defect 1

Offset: **2** (in.)

Condition: ☐ Sound ☐ Cracked ☐ Root Intrusion ☐ Loose Brick ☒ **Deteriorated**

DETERIORATED FRAME  
ADJUSTMENT; FRAME OFFSET

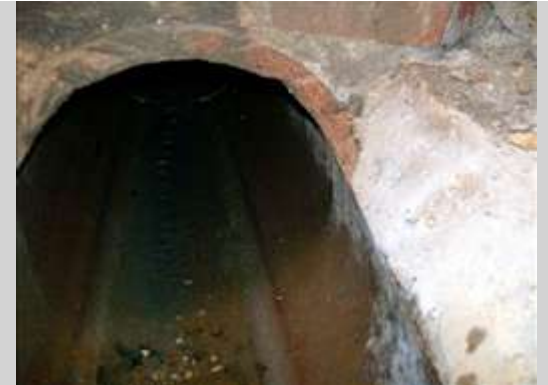
12 in. Circular Gravity Sewer  
Pipe In @ 6 O'Clock

DETERIORATED FRAME ADJUSTMENT;  
FRAME OFFSET

Pipe Height: (in.) Direct  
Pipe Material: **Clay** ☐ Pipe Lined  
Invert Depth: **6.66** (ft.) Flow Characteristics: **Fast**  
Deposits: ☒ None ☐ Mud ☐ Sludge ☐ Debris ☐ Grease  
Silt Depth: (in.) Deposits Extent:  
Infiltration: **None** Pipe Seal Cond: **Cracked**

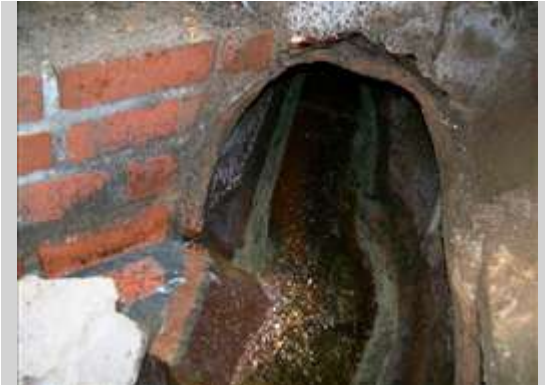
12 O'Clock Outflow  
Pipe Out @ 12 O'Clock

DETERIORATED FRAME ADJUSTMENT;  
FRAME OFFSET

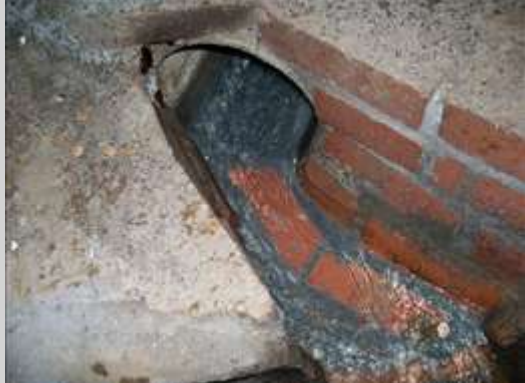
Pipe In @ 9 O'Clock

Infiltration: **None** Pipe Seal Cond: **Sound**
